CONSTRUCTION COMPLETION REPORT - REV 0

OU-3 Remedial Action – Anniston PCB Site

Submitted By: Golder Associates Inc.
3730 Chamblee Tucker Road
Atlanta, GA 30341 USA

December 2017 **1302962CQA**

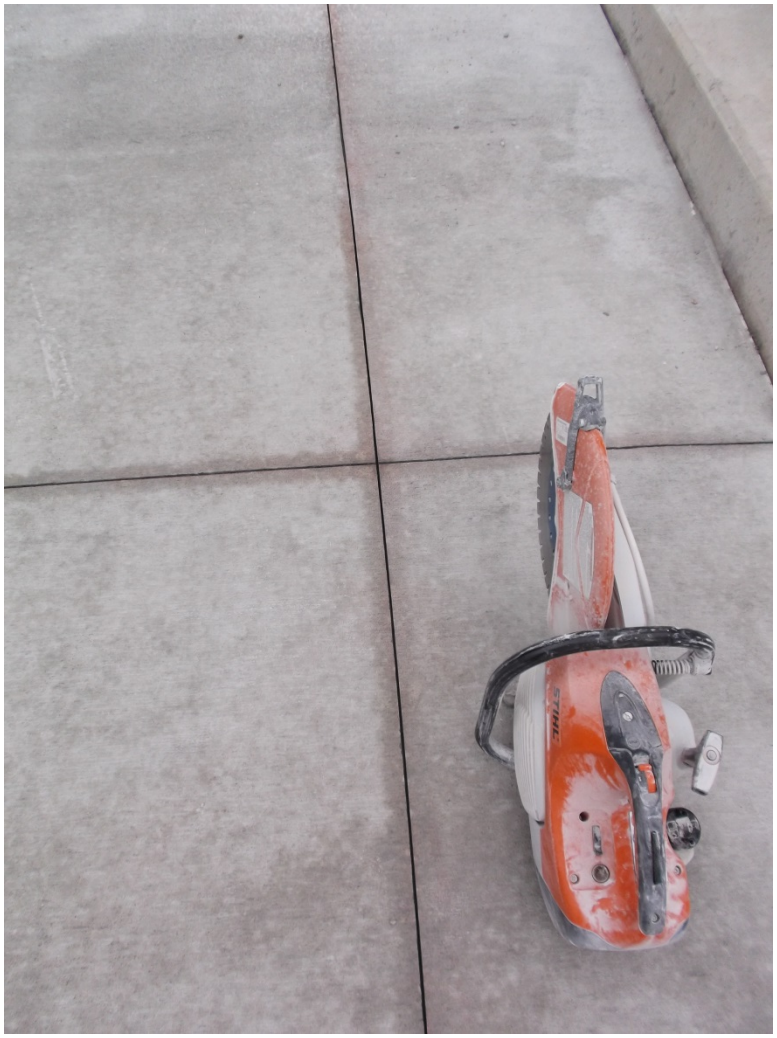
Photograph 4: Cutting of concrete contraction joint

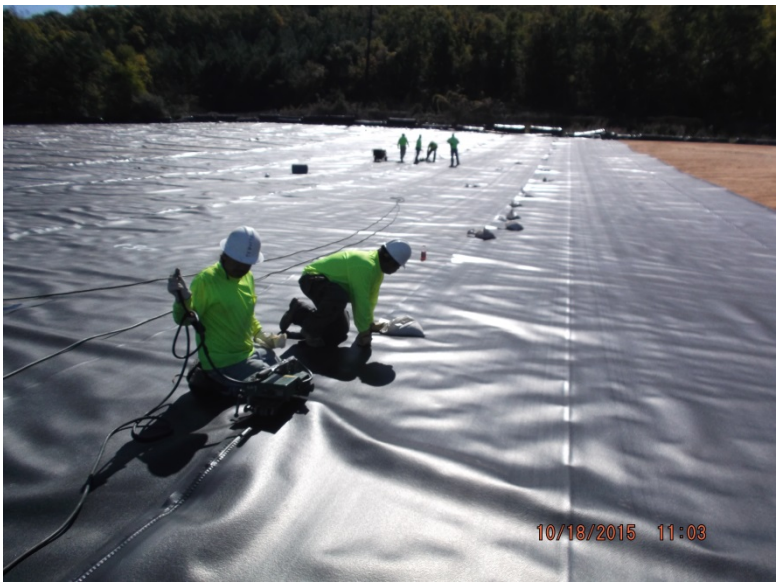
Fusion seaming

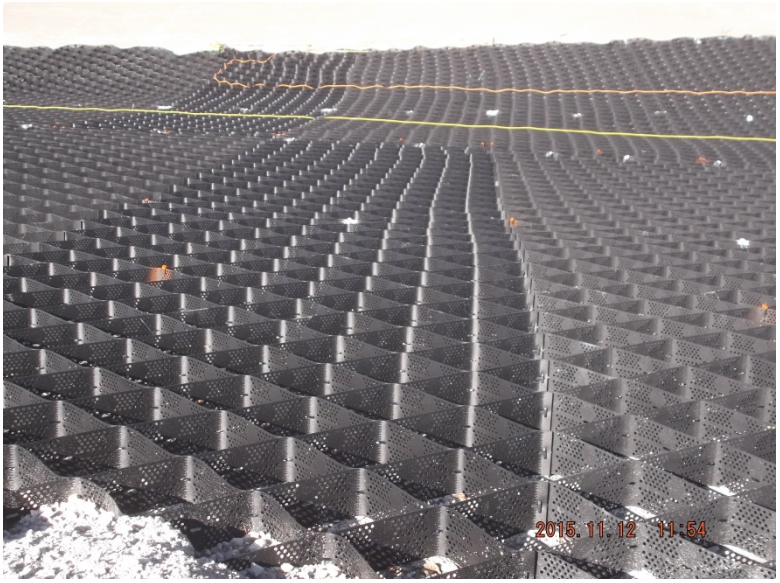
Geocell install C&D

Showing a panel layout that does not have the correct amount of stakes (anchors)

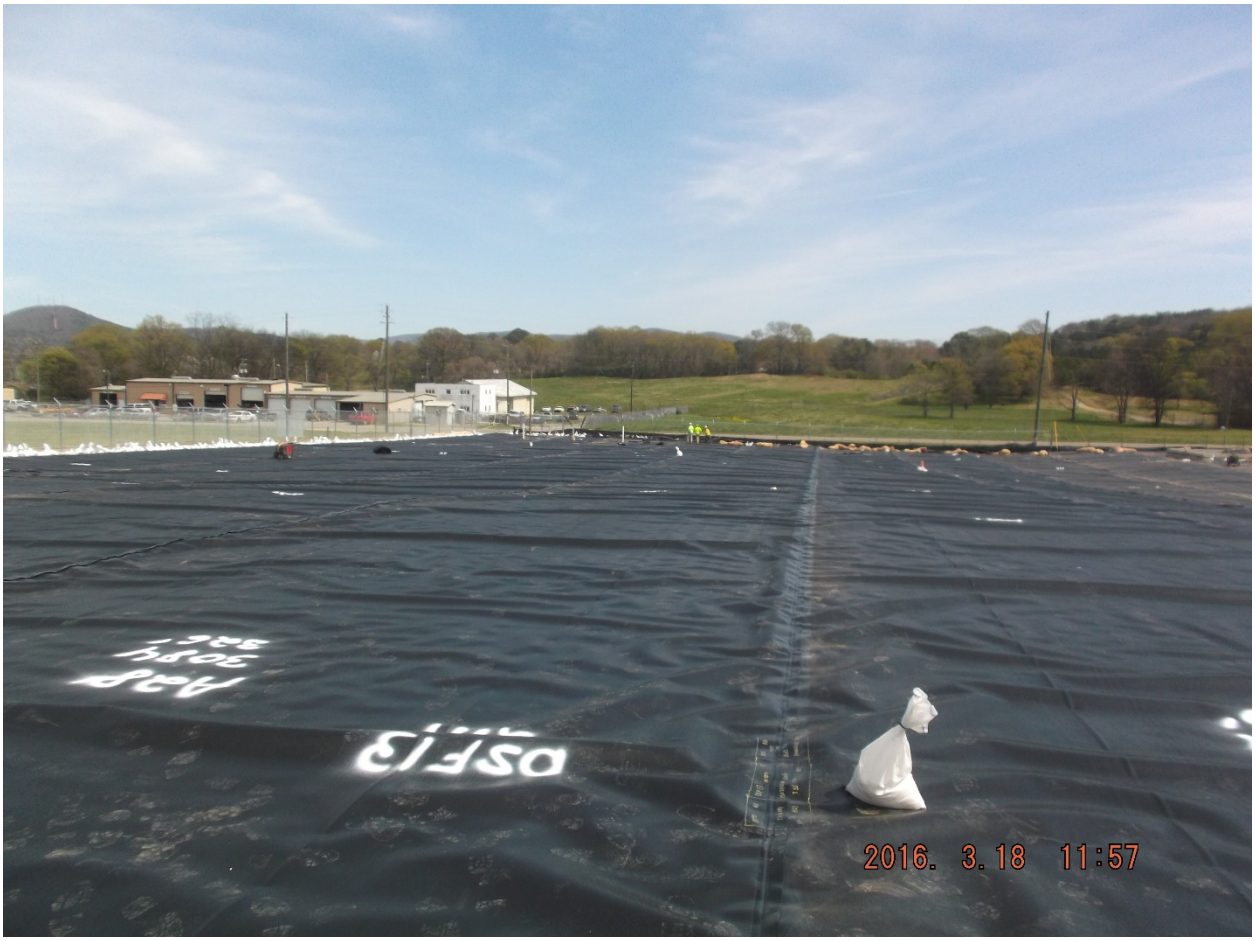
Liner north side area A

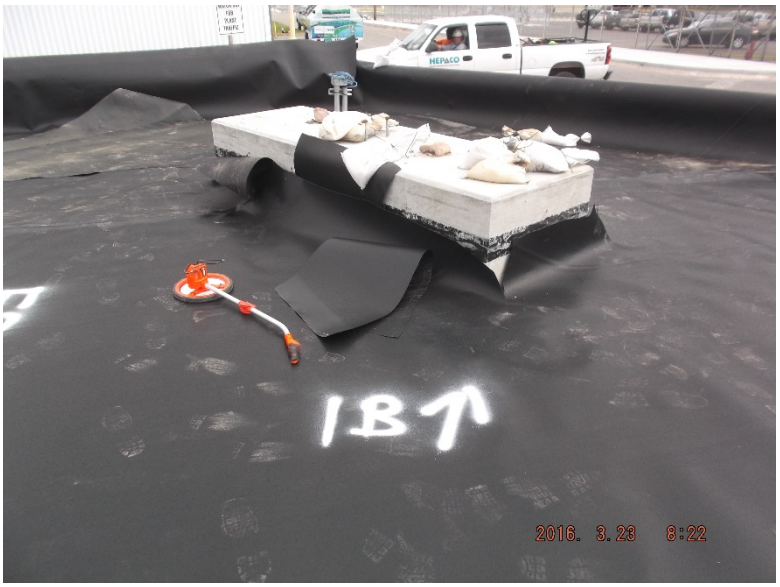
Start deployment of liner Area E

Area not lined in Area E b/c wall is not complete SW corner
